Manhole Inspection Summary

Manhole # S43W__004MH

Location Address: **1244 e. fort ave.**

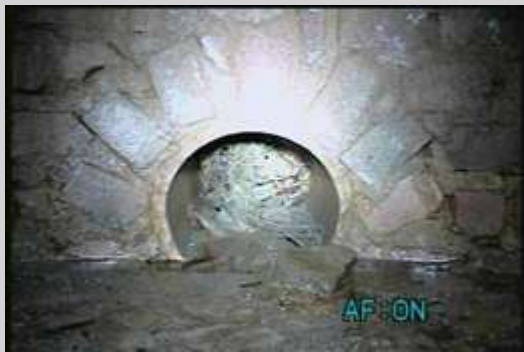
12 O'Clock Outflow

8 in. Circular Gravity Sewer
Pipe Out @ 12 O'Clock

Deposits: ☐ None ☐ Mud ☒ **Gravy** ☐ Debris ☐ Grease

Silt Depth: **6** (in.) Deposits Extent: **Heavy**
